United States Department of the Interior  
National Park Service**National Register of Historic Places Registration Form**

**1. Name of Property**Historic name: Weblin House (Additional Documentation and Boundary Decrease)Other names/site number: DHR ID# 134-0035

N/A**2. Location**Street & number: 5588 Moores Pond RoadCity or town: Virginia Beach State: VA County: Independent CityNot For Publication: N/A Vicinity: N/A**3. State/Federal Agency Certification**

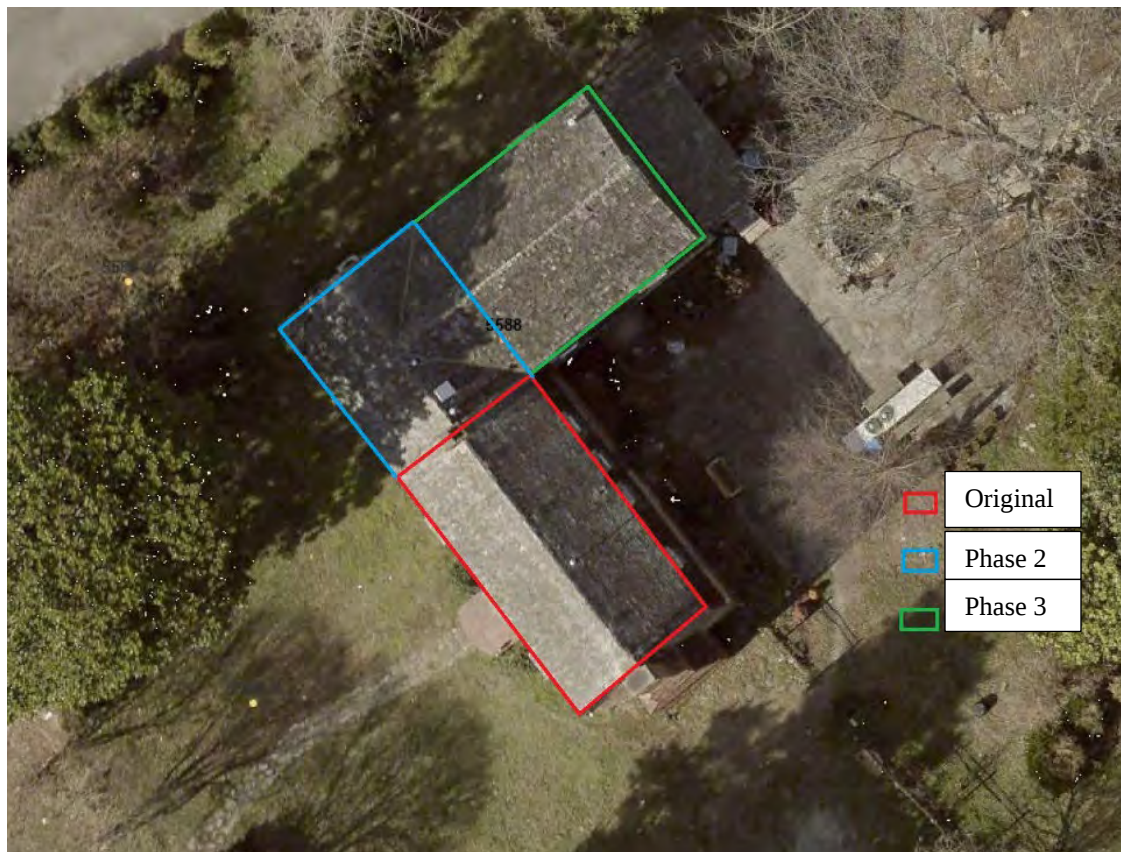
Figure 1. Phases of construction

The Weblin House has an original section at the southeast (Phase 1) with an addition at the northwest dating to the late 1930s<sup>2</sup> (Phase 2) and a rear ell (Phase 3) extending from the Phase 2 addition, built ca. 2000.

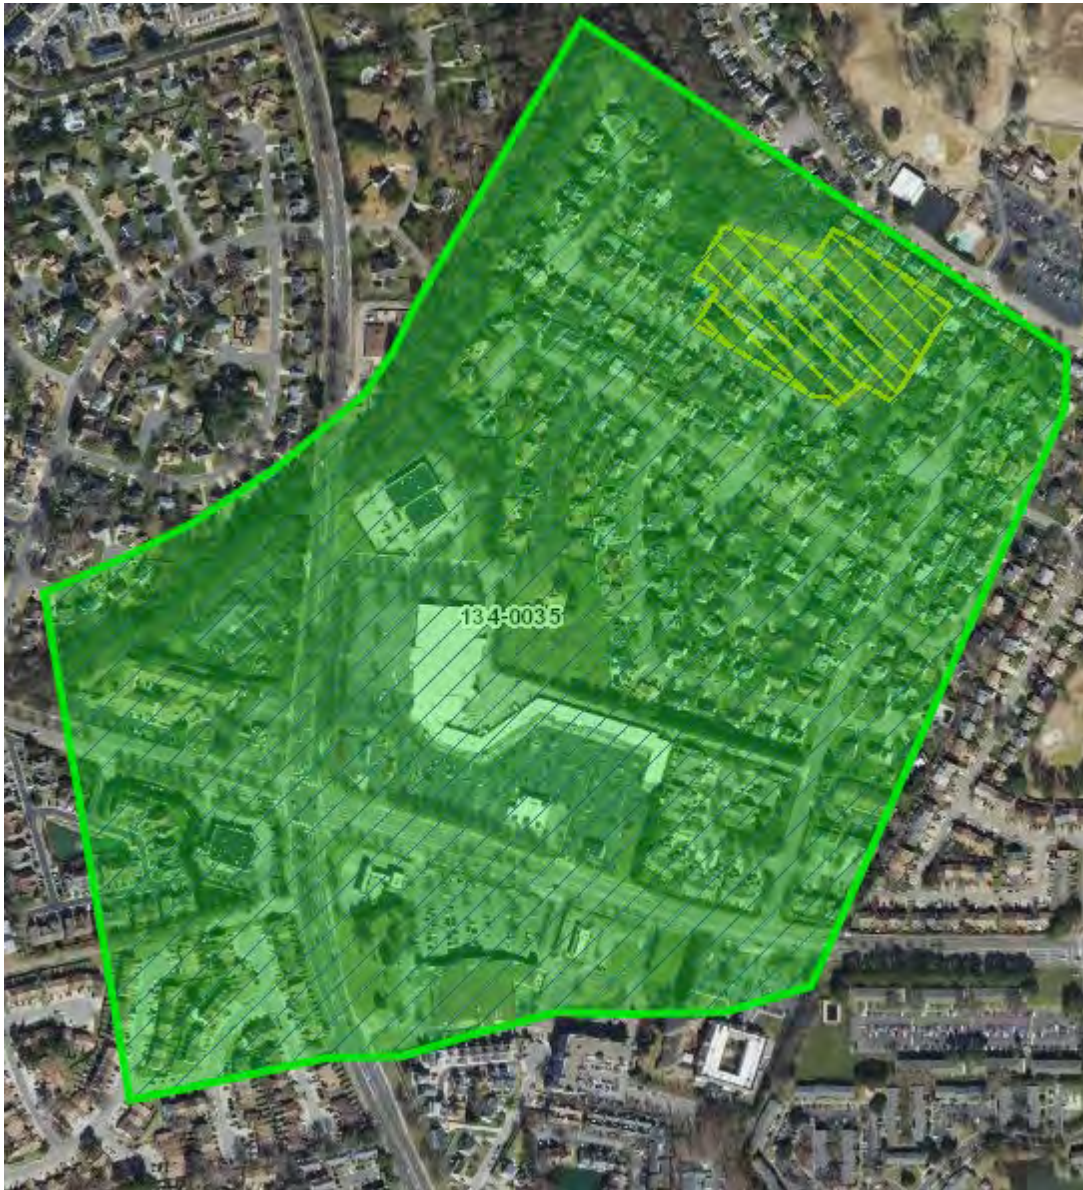
Figure 2. Former boundary with current development. Source: VDHR, VCRIS survey database.

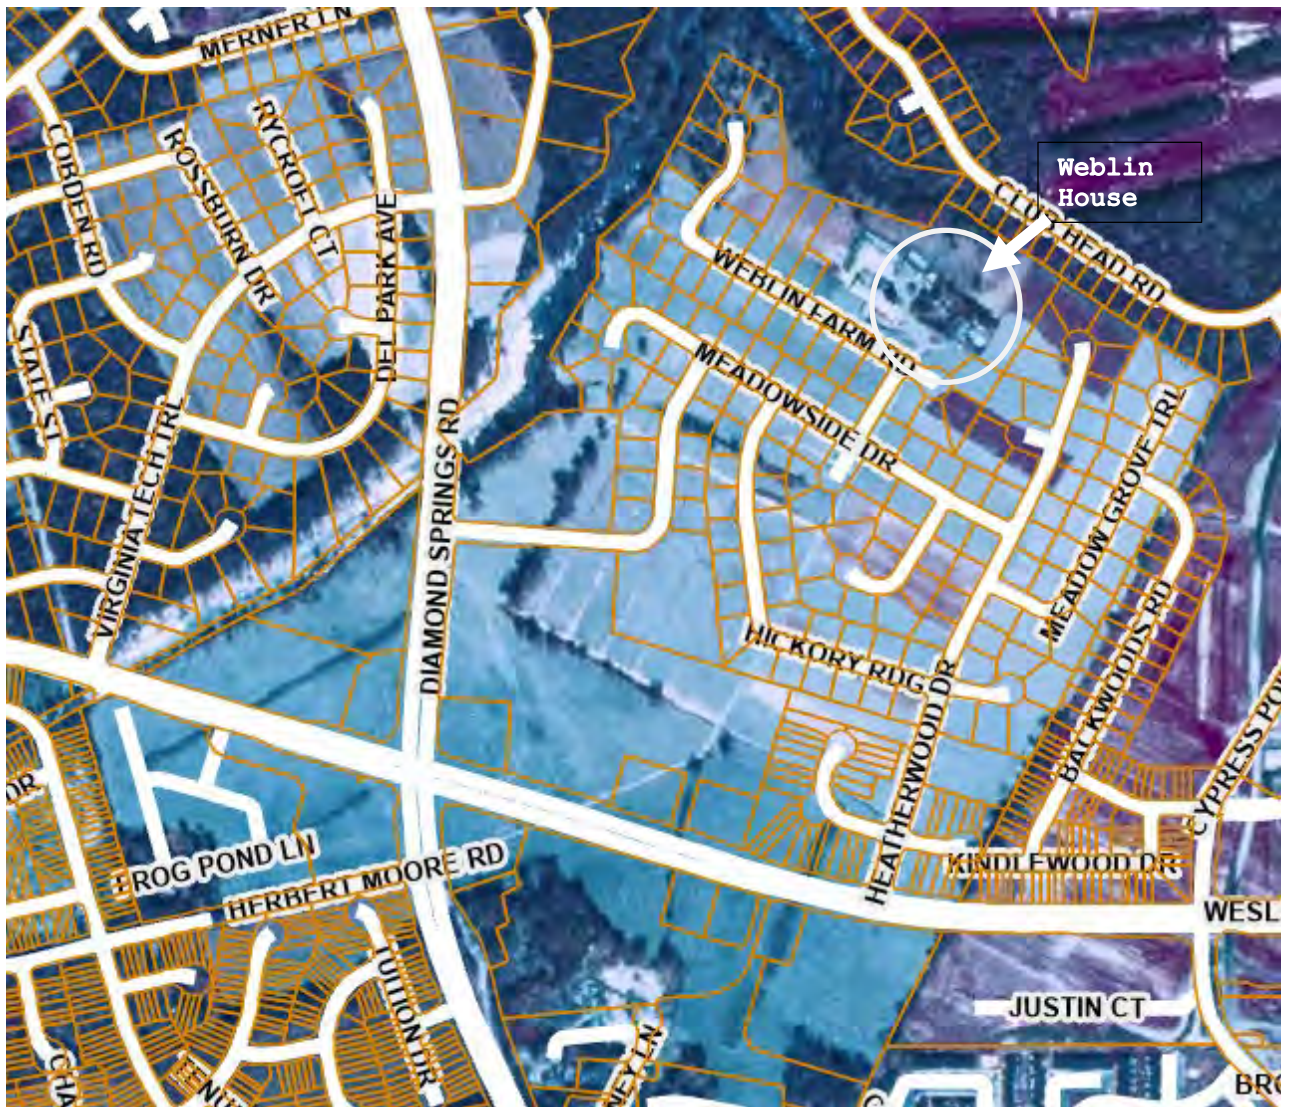
Figure 3. 1982 aerial photo with current parcels overlaid. Source: Virginia Beach GIS.

Much of the understanding of the evolution of the site comes from comparative analysis of aerial photography, given a dearth of maps and site plans. In 1937, the house with its northwest addition, the barn and silos, two secondary dwellings, and garages are evident. A farm road on a southwest axis from the house cuts through agricultural fields. Sometime between 1958 and 1982, a long, low shed, northeast of and perpendicular to the extant shed, was built. Between 1982 and 1994, residential subdivisions to the north, east, and southwest were built on the former agricultural fields. In 1998, additional homes ranging from the east to the northwest were under construction. Between 1998 and 2002, the rear ell was added to the house, and the pool and garden shed were added. Between 2002 and 2007, the eastern dwelling was enlarged, and the northeastern long shed was demolished.<sup>1</sup>

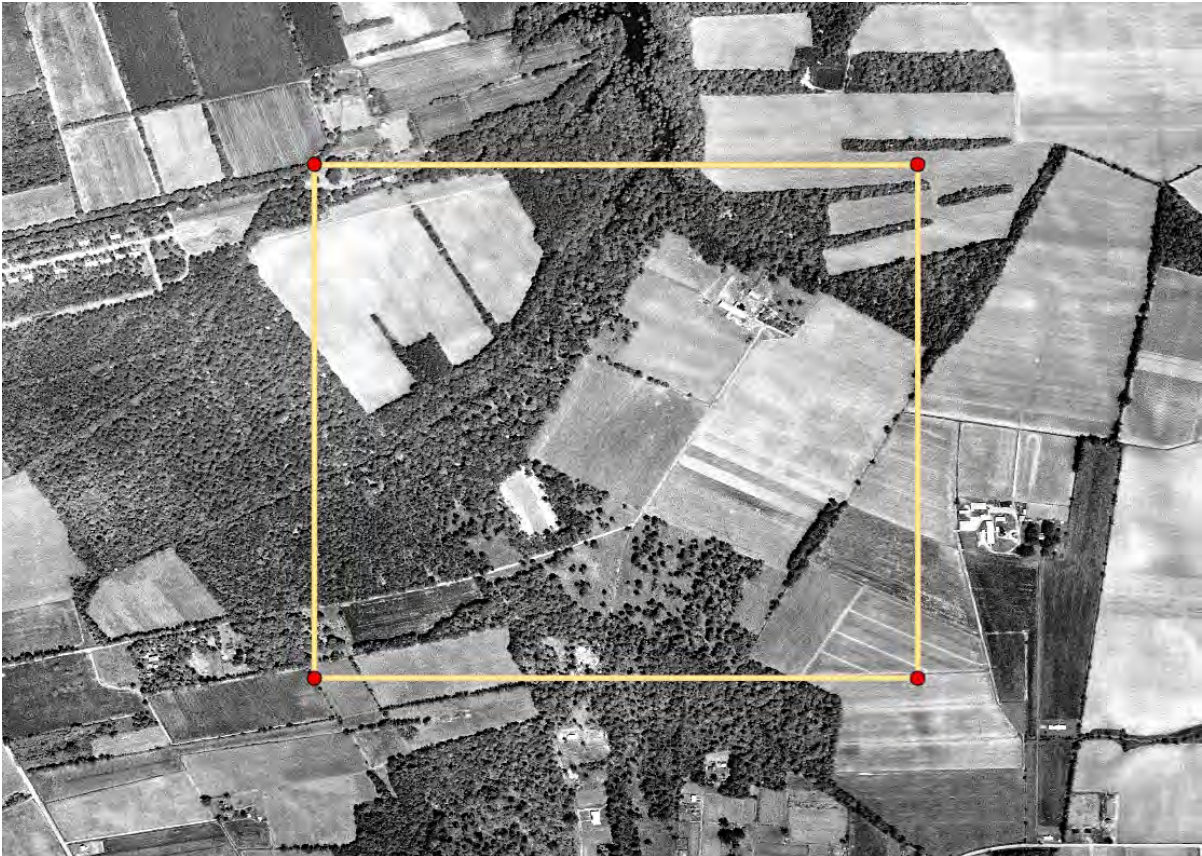
Figure 4. 1974 nomination UTM references overlaid on 1958 aerial photograph

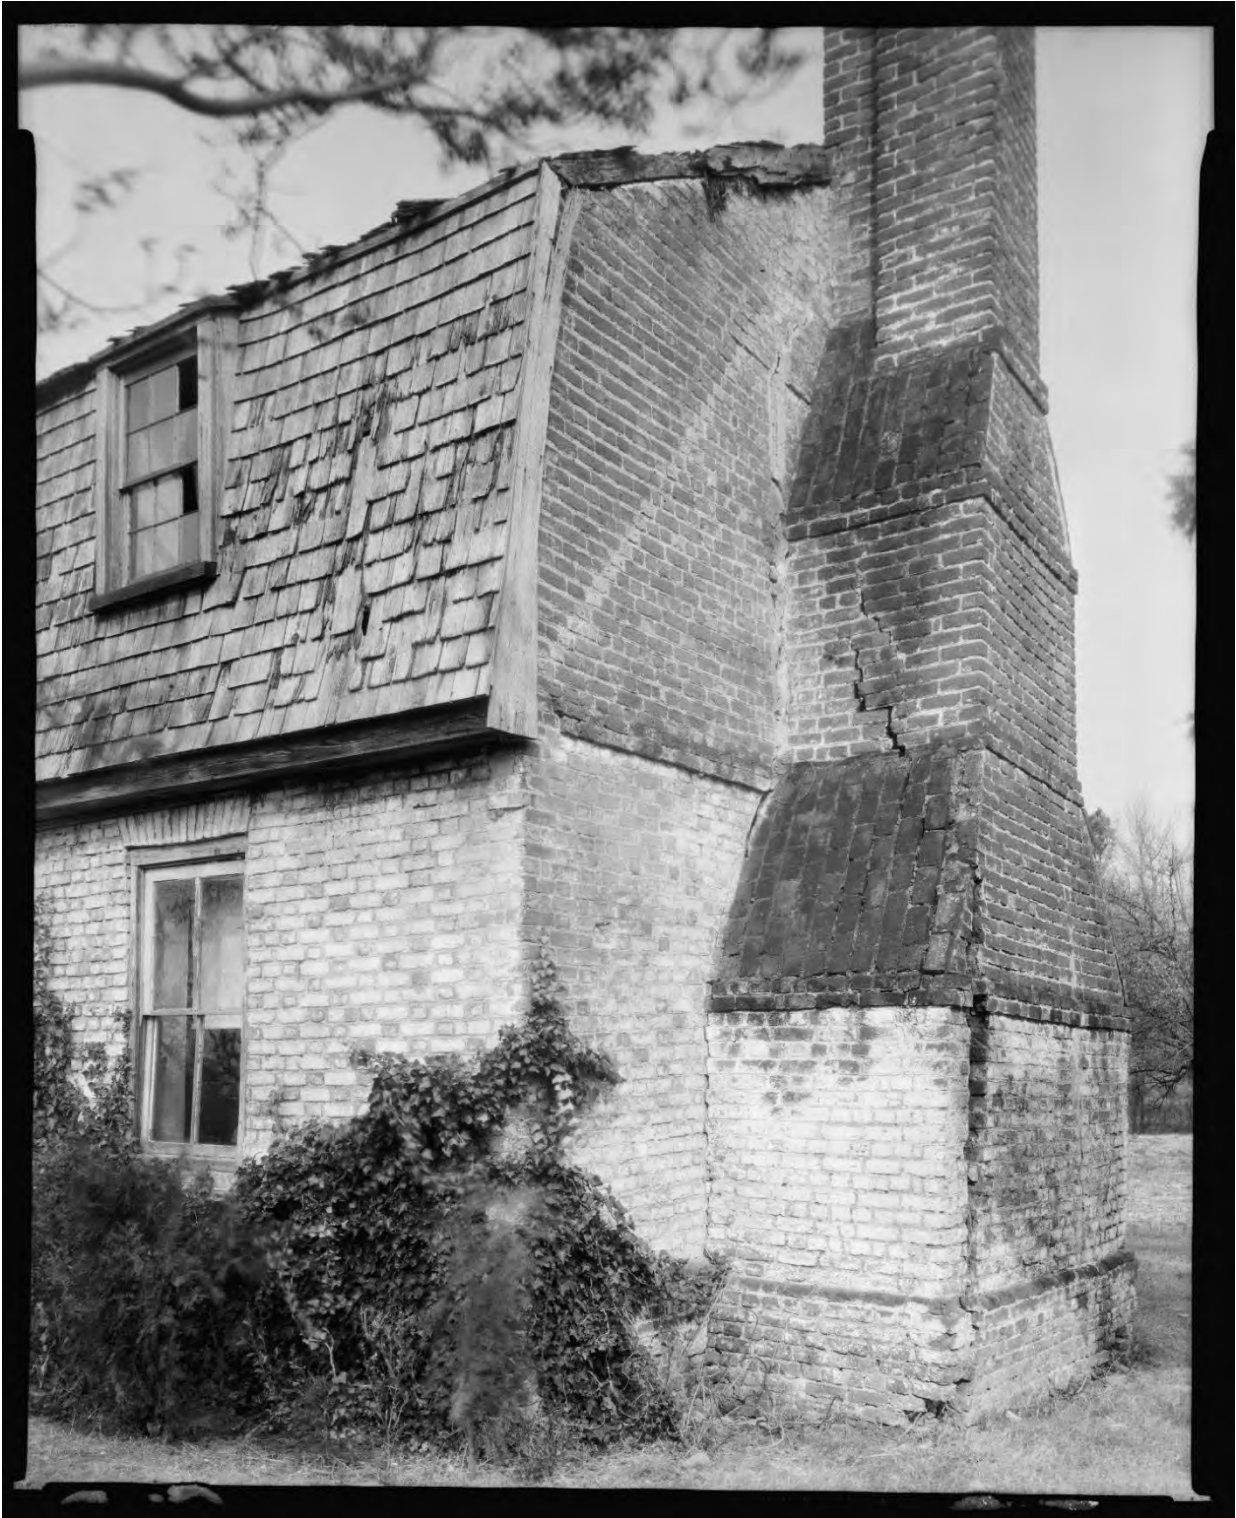
Figure 6 Photo of the Weblin House, Frances Benjamin Johnston.

Phase 2 of the house was built sometime in the 1930s. It is evident in a 1937 aerial photo but not in photos by Frances Benjamin Johnston shot between 1930 and 1939 for the Carnegie Survey of the Architecture of the South.<sup>3</sup> Originally Phase 2 had a gable roof, but after 1997<sup>4</sup> it was raised to be a gambrel roof, slightly shorter than the gambrel roof of Phase 1. A prominent seam on the facade divides the Phase 1 brickwork from that of Phase 2, which is laid in seven-course American bond, with a header course at the eave and no water table. The Phase 2 facade has

<sup>3</sup> Frances Benjamin Johnston, Three photos of the Weblin House, Carnegie Survey of the Architecture of the South, 1930s, <https://www.loc.gov/pictures/item/2017891275/>. See Figures 6-8 in this nomination.

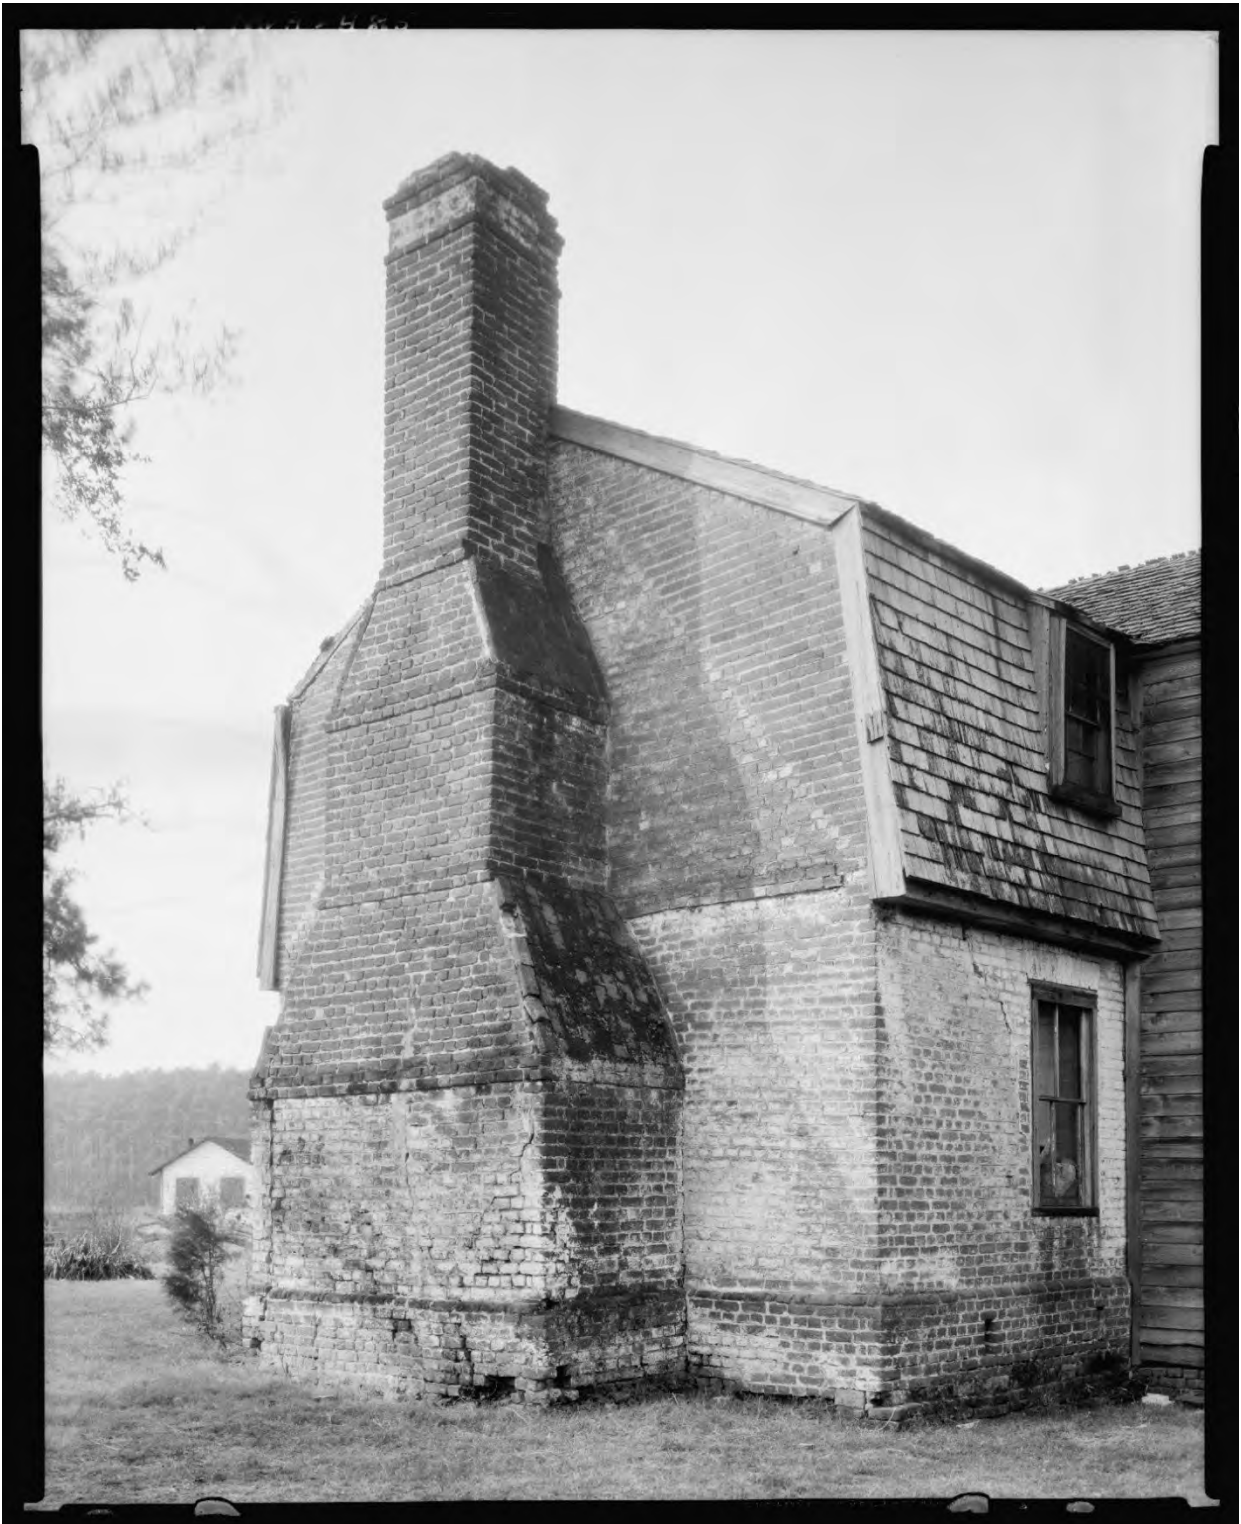
Figure 7 Photo of the Weblin House, Frances Benjamin Johnston.

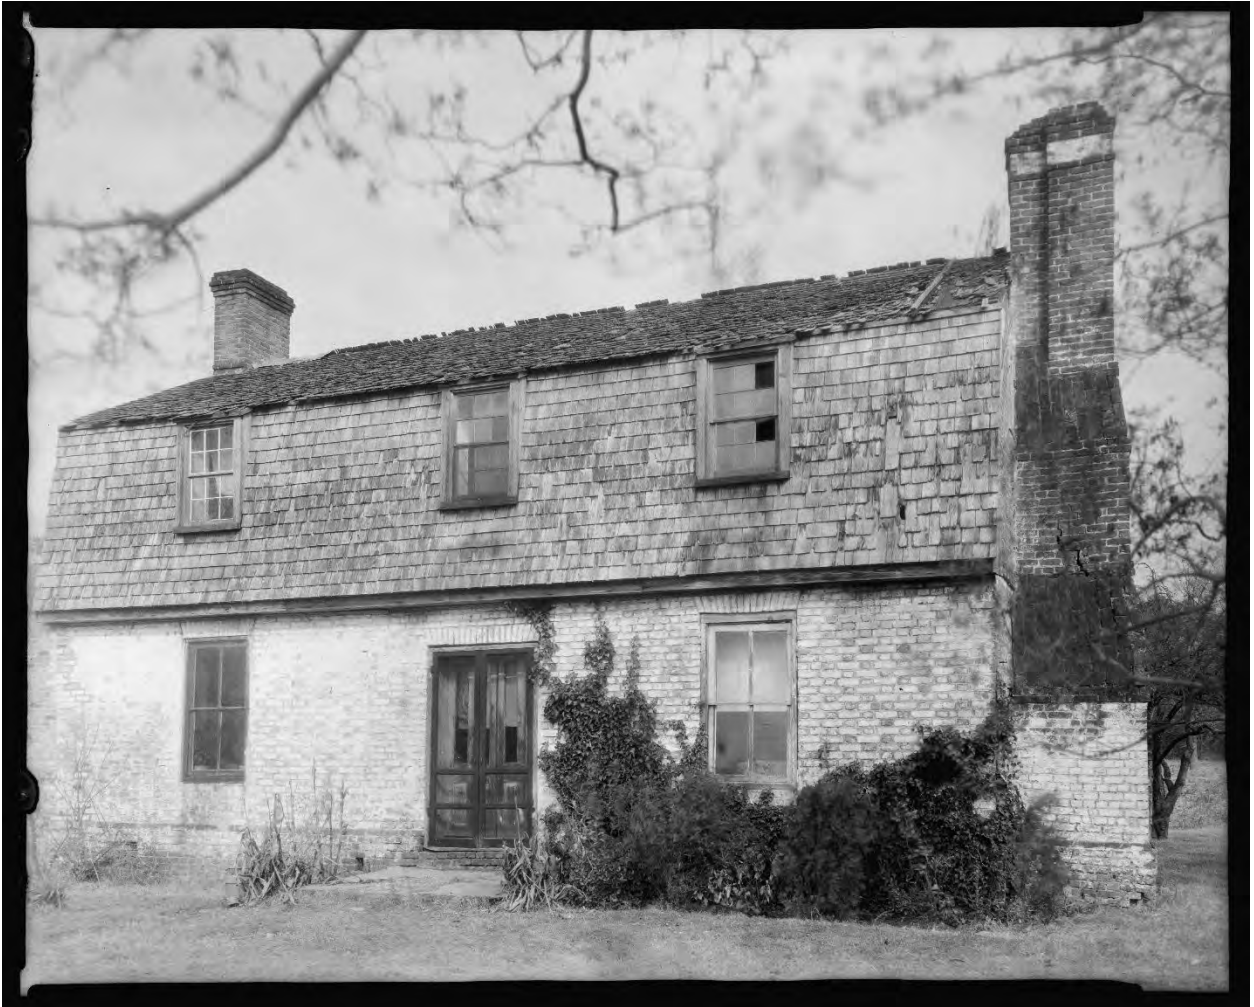
Figure 8 Photo of the Weblin House, Frances Benjamin Johnston.
